SUBJECT: MODE Spanner Nut (Oxygen Gauge)

Modular Oxygen Diving Equipment (MODE).

Ref: This is a response to FAR 17-MODE-001 and FAR 17-MODE-003

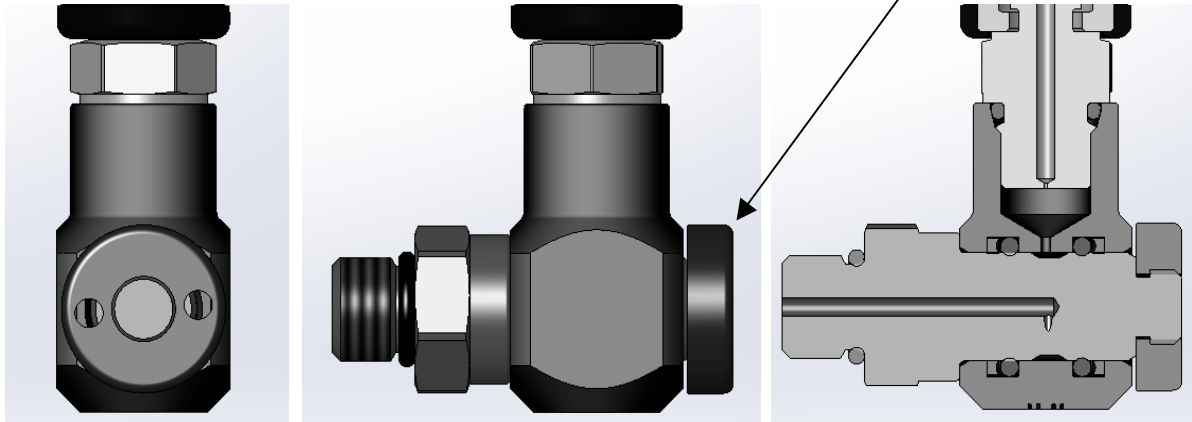
During MODE dive ops, high pressure oxygen leaks were discovered due to the loosening of Spanner Nut PN 488035.

NOTE 2: Tests conducted at Aqua Lung indicate that applying Loctite 222 to the male threads of the Gauge Swivel Axis (48708) prior to reinstalling the Spanner Nut, will increase the mechanical resistance (removal torque) and should prevent the inadvertent loosening of the Spanner Nut.

1. Remove Spanner Nut (488035).
2. Ensure the Swivel Axis (487086) and Spanner Nut (488035) are clean and dry.
3. Ensure the Loctite 222 solution is well mixed by shaking vigorously prior to use.
4. Apply Loctite 222 to male threads of Swivel Axis (487086) IAW Loctite instructions.
5. Reinstall and torque Spanner Nut (488035) onto the Swivel Axis IAW MODE O&M Manual, Table 6-5.
6. Allow 24 hours for the Loctite to cure before conducting Joint Tightness Test IAW MODE O&M Manual, Paragraph 4-5.1.2.
