SUBJECT: MODE Over Pressure Valve (OPV)

Modular Oxygen Diving Equipment (MODE).

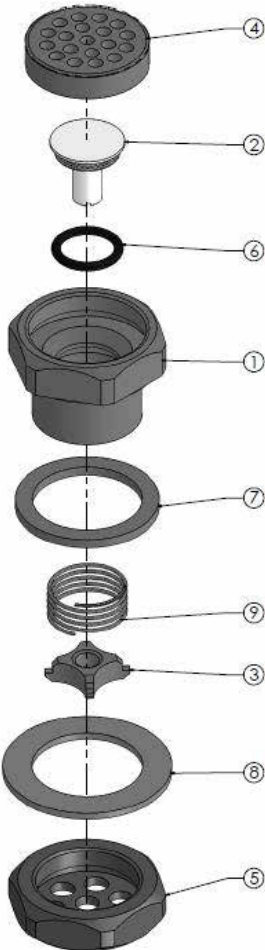
During extended UBA wet lay-up periods where repet dives will be made using the same ExtendAir cartridge, the alkaline environment inside of the breathing bag effects the structural integrity of the plastic OPV male threads. The chemical effect on the plastic male OPV threads has been so severe that some OPVs have cracked and broken.

1. Remove the existing OPV P/N 488190.
2. Ship to Aqua Lung America, Attn: Steve Reilly, 2340 Cousteau Ct Vista, CA 92081.
3. Install new aluminum OPV P/N 101200.
4. Conduct gas tightness test IAW MODE O&M before placing rig back into service.
