MILITARY TECHNICAL BULLETIN

SUBJECT: Failure of the Powerline Airway Hose PN 15740

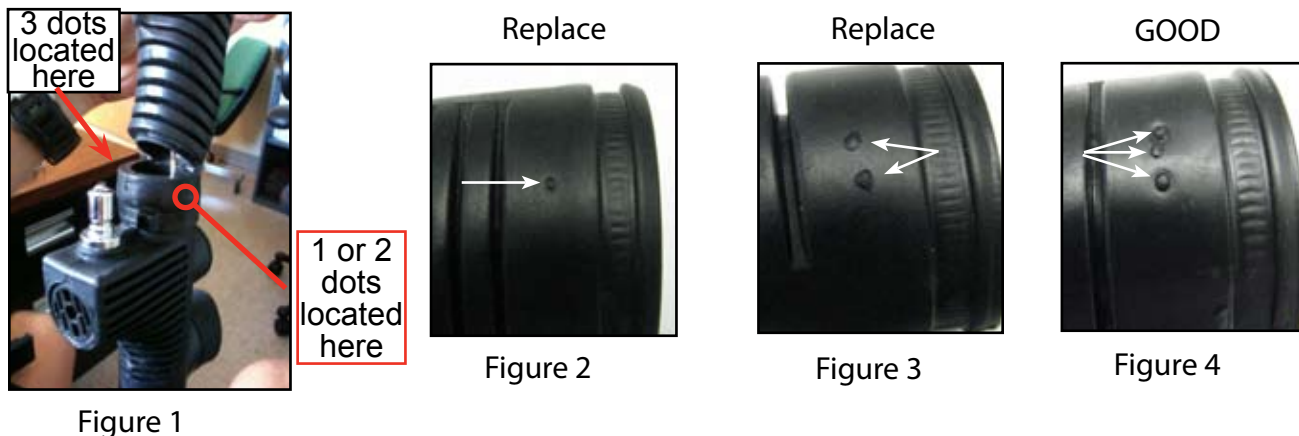
- **Affected Units: Powerline Ribbed Hoses with one (1) or two (2) dots on the lower end of the Hose**
- **Problem: This ribbed hose has a tendency to tear at the lower end when excessive bend is applied to the lower inflation unit**

It has come to Aqua Lung's attention that during normal diving operations the ribbed hose may separate beneath the last rib nearest the lower unit (Figure 1).

As the above comments show, the the original Powerline hose tended to get less flexible over time and may fail during use. The Powerline is fairly rugged but not entirely impervious to extreme operating conditions.

Aqua Lung has redesigned the Powerline Airway Hose with a more flexible compound. Hoses with one dot only (Figure 2) or two dots only (Figure 3) should be replaced with newer hoses that have three dots (figure 4). **These three dot hoses have two dots on the opposite side.** These are correct to use. Figure 1 shows the location of the dot markings. Owners of affected units are requested to upgrade these older hoses on site to prevent pre-mature failure. Please contact Aqua Lung America if you have Ribbed Airway Hoses that have one or two dots only on them. Aqua Lung America will provide replacements at no cost. The Powerline Airway hose replacement and testing procedures are contained in the CSAV Technical Manual (09/07- 11/10) (10.07), illustrated on pgs 38-40. This technical manual is available for viewing or download on the Aqua Lung Military and Professional website. As always, local command instructions/directives take precedence over manufacturers recommendations.
