## **SUBJECT: Heat Exchanger Torque Specification Change of Apeks TX/ATX/XTX 2nd Stages**

- **Affected Units: All 2nd stages/octopus that have or have not undergone a scheduled overhaul.**
- **Problem: Potential damage to the Case**

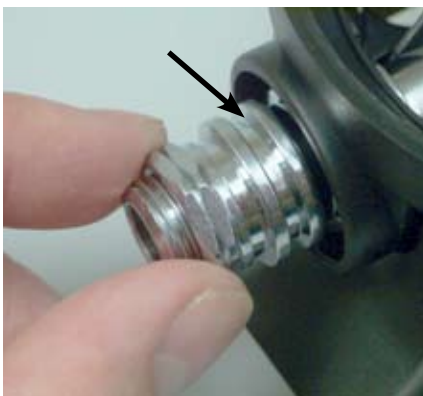
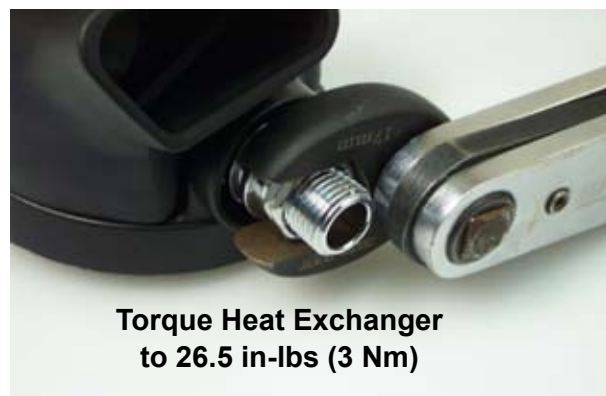
When disassembling the TX/ATX/XTX second stage, we request that you perform a visual inspection to confirm no damage to the Case from the Heat Exchanger. In most cases, the Case will show no damage and may be continued in service. The 2nd Stage may be reassembled and the Heat Exchanger torqued to **26.5 in-lbs (3 Nm)**. If damage from the Heat Exchanger is noted, the Case may no longer be used.

After inspection, if you find that a second stage Case that has damage from the Heat Exchanger, please contact our Military Department for a replacement. You can reach the Military Product Manager at 877-253-DIVE or 760-597-5048 or at [rbedard@aqualung.com](mailto:rbedard@aqualung.com) Your cooperation is much appreciated.
